# **Navajo Abandoned Uranium Mine**

## **Site Screen Report**

## **Saytah Canyon AUM Site**

### **Navajo AUM Northern Region**

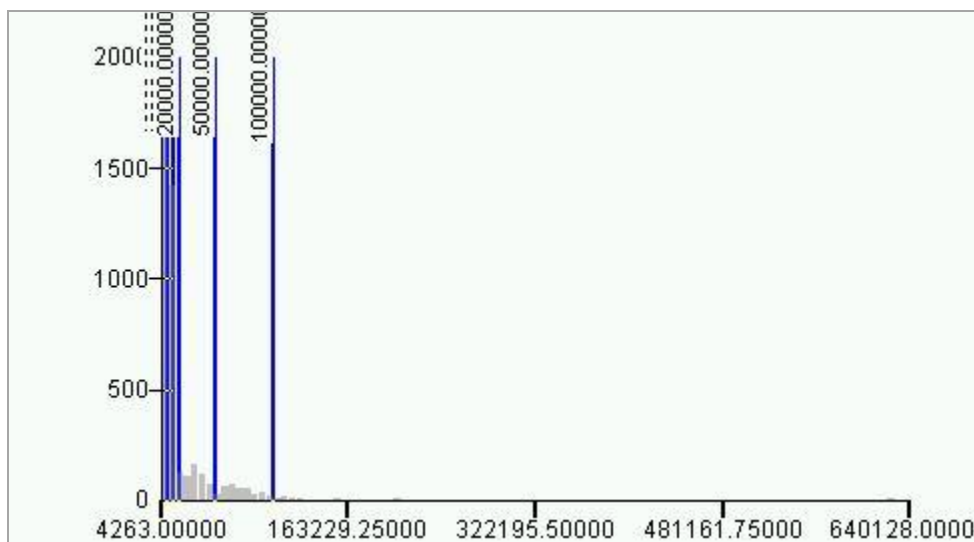
The following chart and statistics were generated by ESRI ArcGIS 9.3.1, and show the general distribution of the site gamma radiation measurements. The horizontal X axis represents the gamma radiation reading levels in cpm (lowest levels to the left). The vertical Y axis represents the frequency of each gamma radiation level.

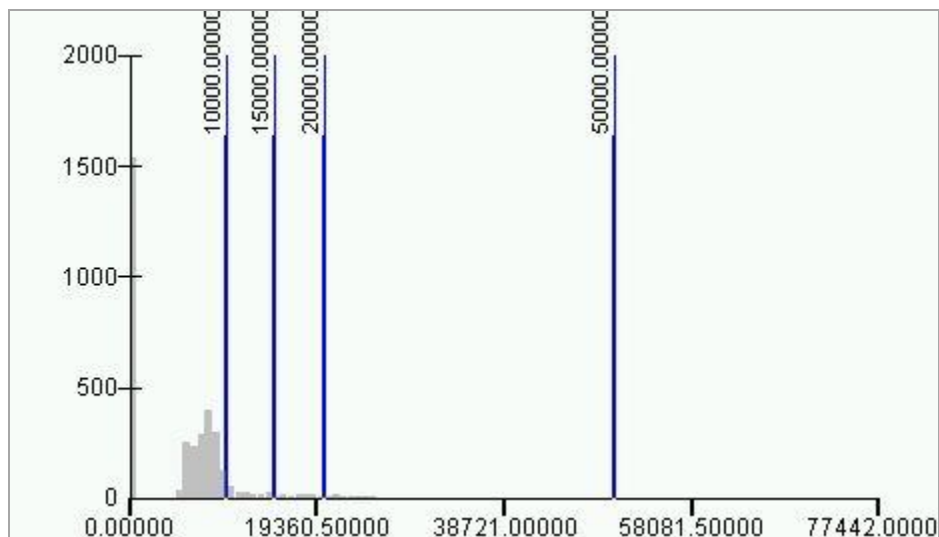
The following chart and statistics were generated by ESRI ArcGIS 9.3.1, and show the general distribution of the site gamma radiation measurements. The horizontal X axis represents the gamma radiation reading levels in cpm (lowest levels to the left). The vertical Y axis represents the frequency of each gamma radiation level.

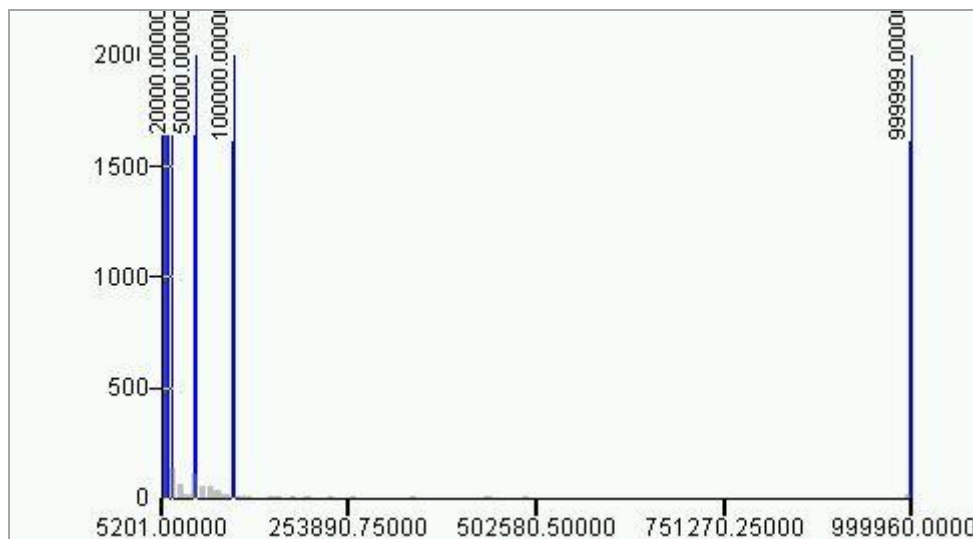
The following chart and statistics were generated by ESRI ArcGIS 9.3.1, and show the general distribution of the site gamma radiation measurements. The horizontal X axis represents the gamma radiation reading levels in cpm (lowest levels to the left). The vertical Y axis represents the frequency of each gamma radiation level.

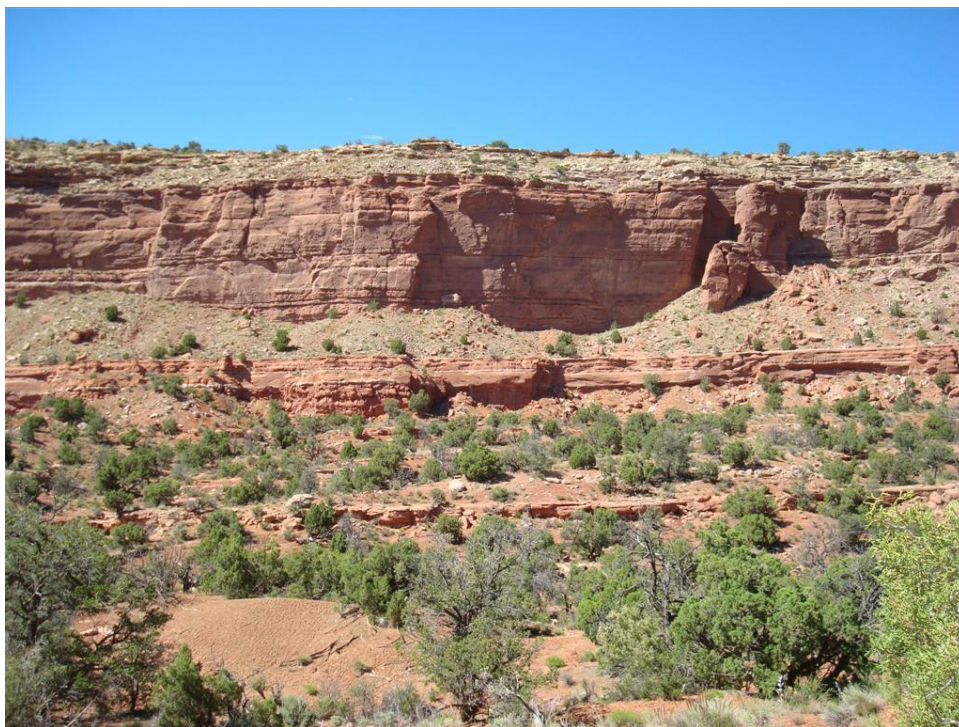
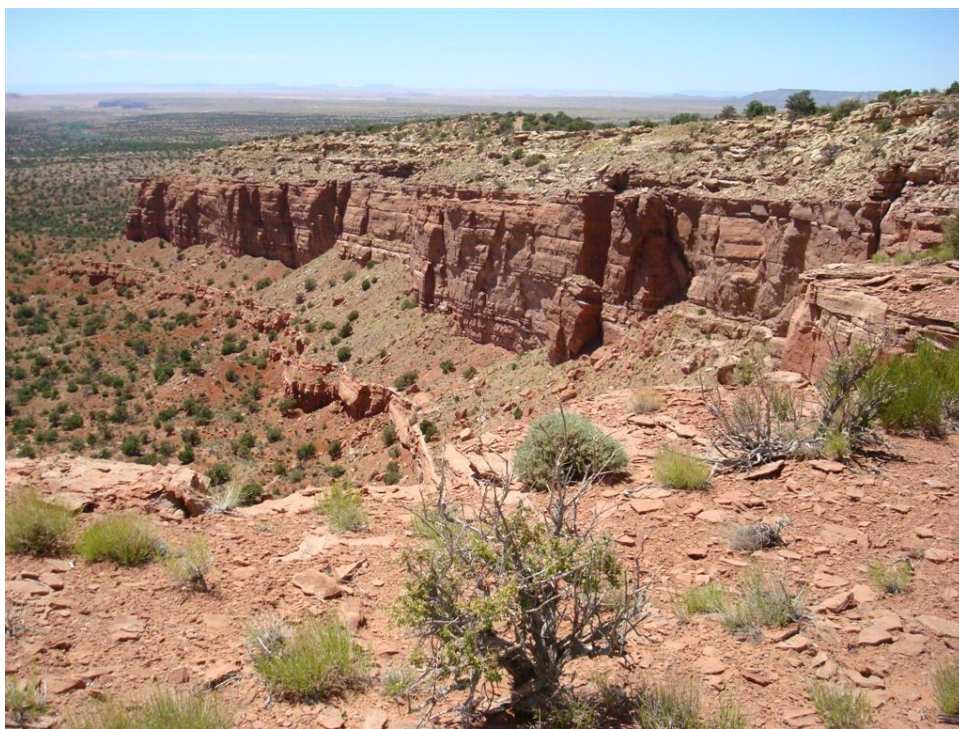
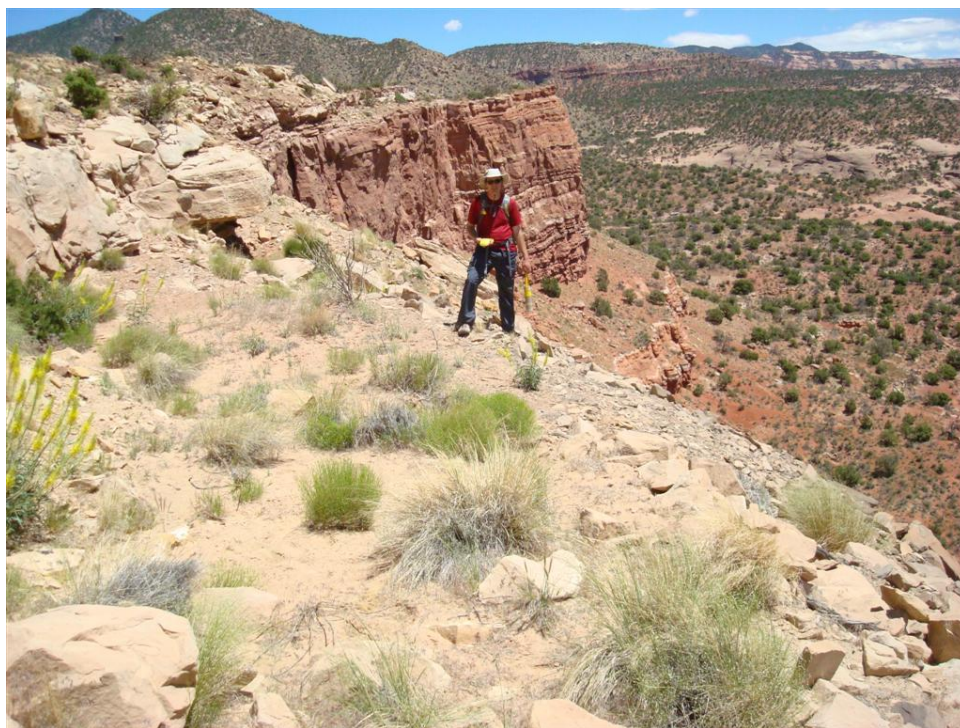
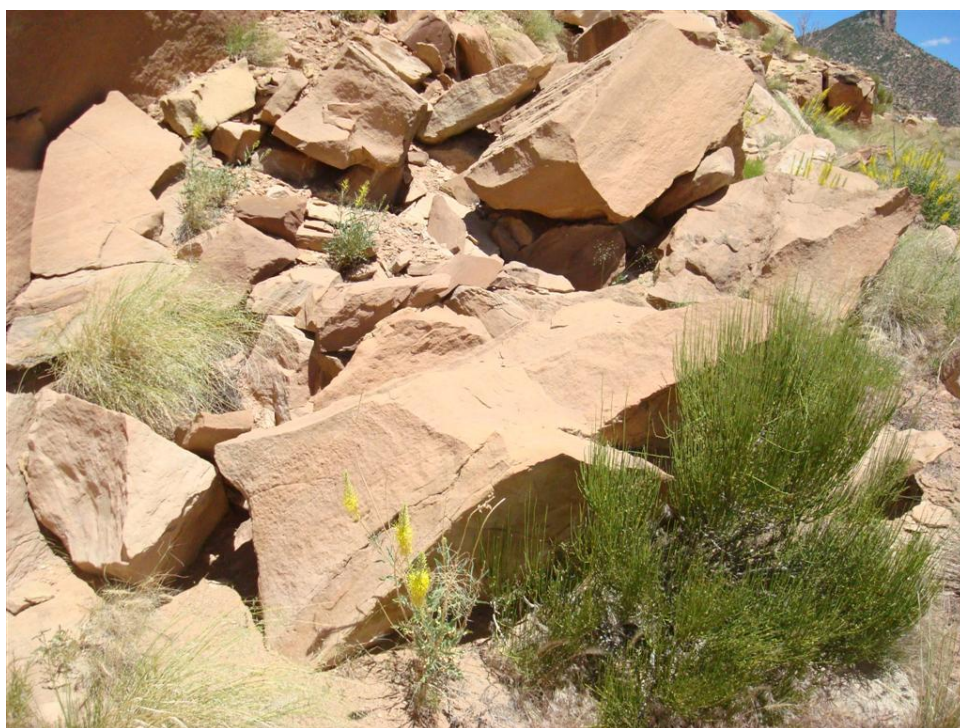
#186 - Scattered waste rock in bench area

Photo 1. Plot 16 site #186

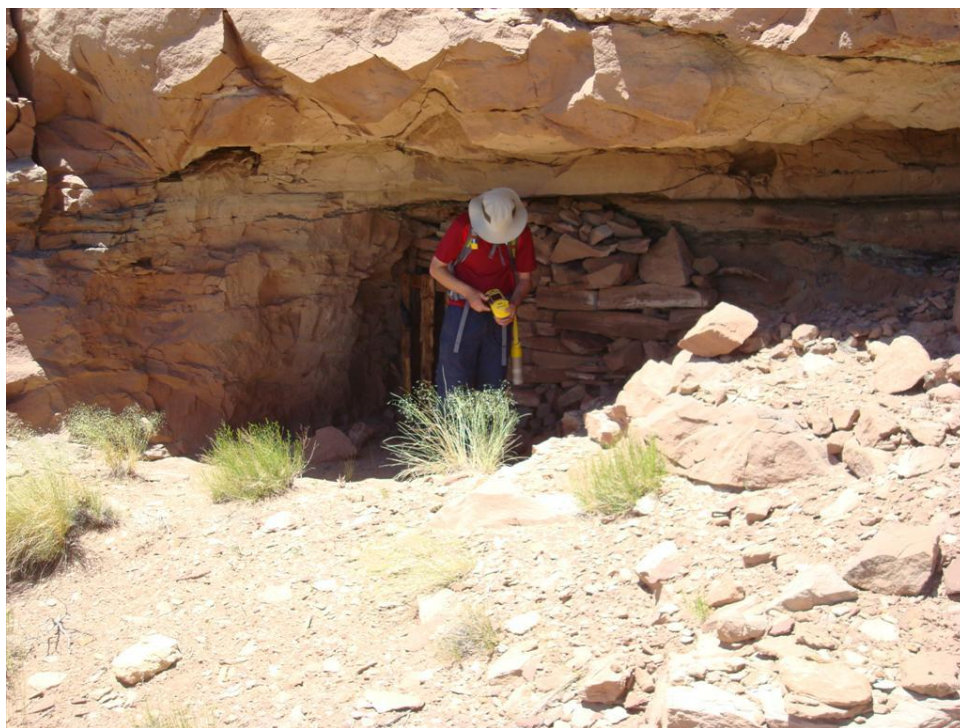
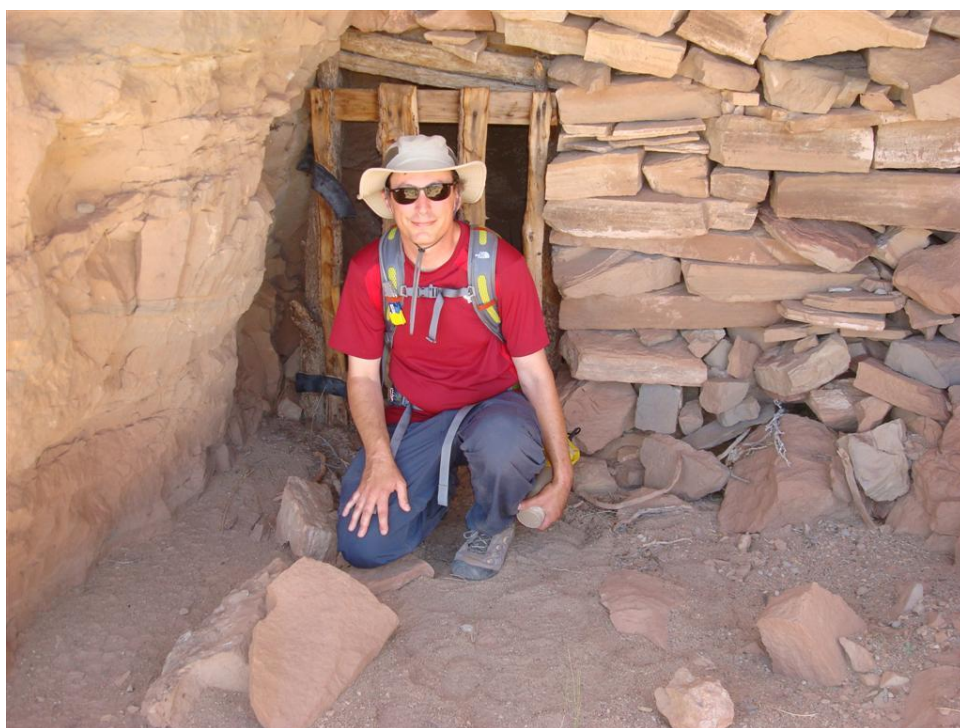
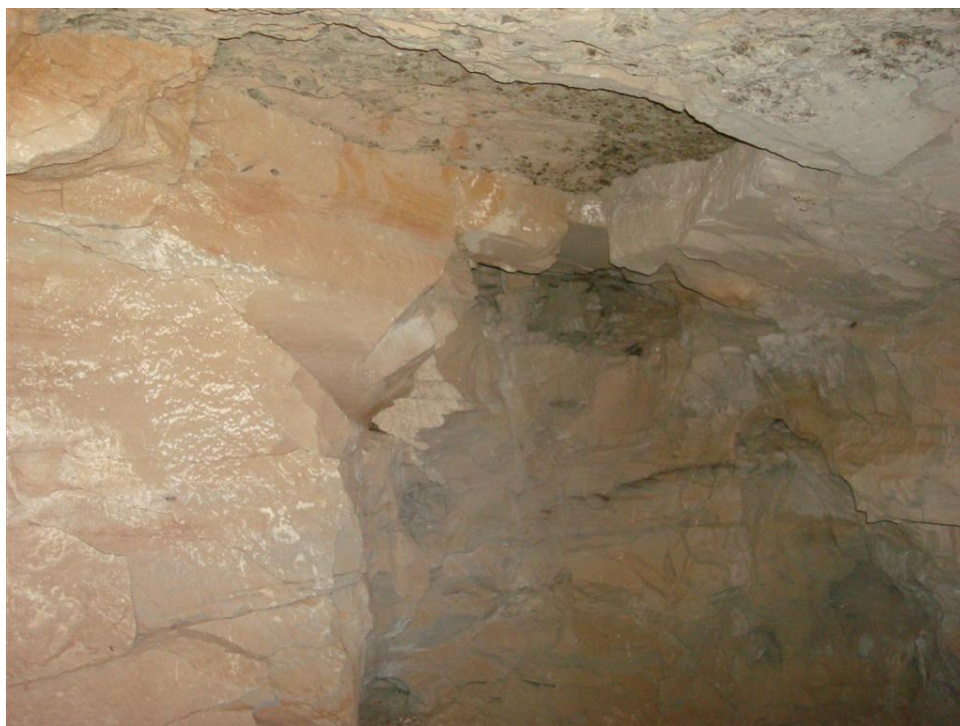
#186 - 1 sealed adit; 1 collapsed adit

Photo 5. Plot 16 site #186, adit

Photo 6. Plot 16 site #186, adit entrance

Photo 5. Plot 16 site #186, adit internal

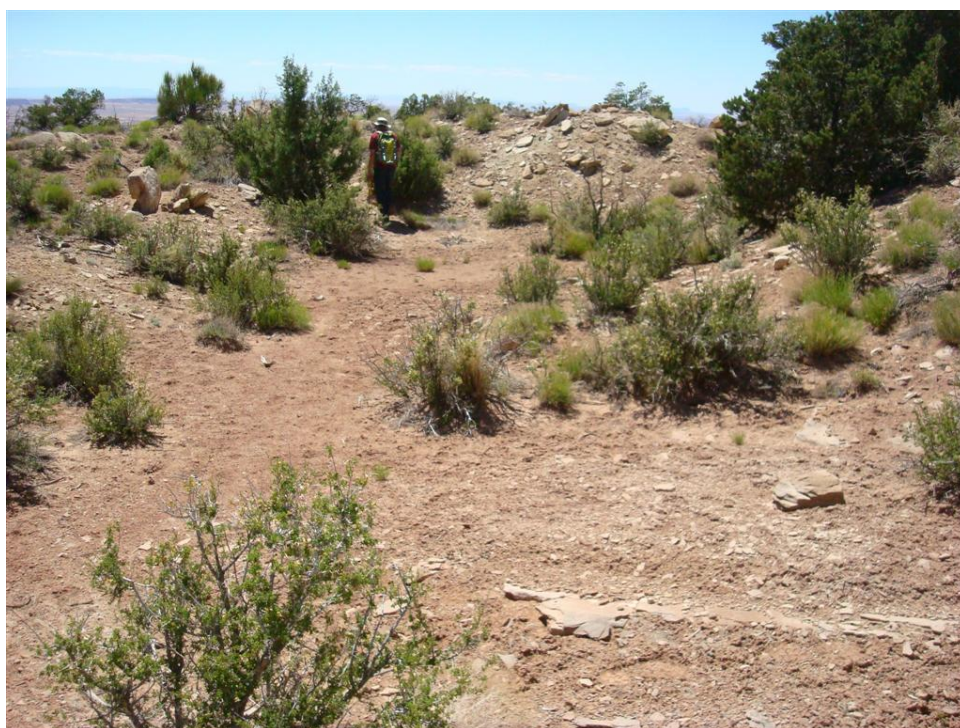
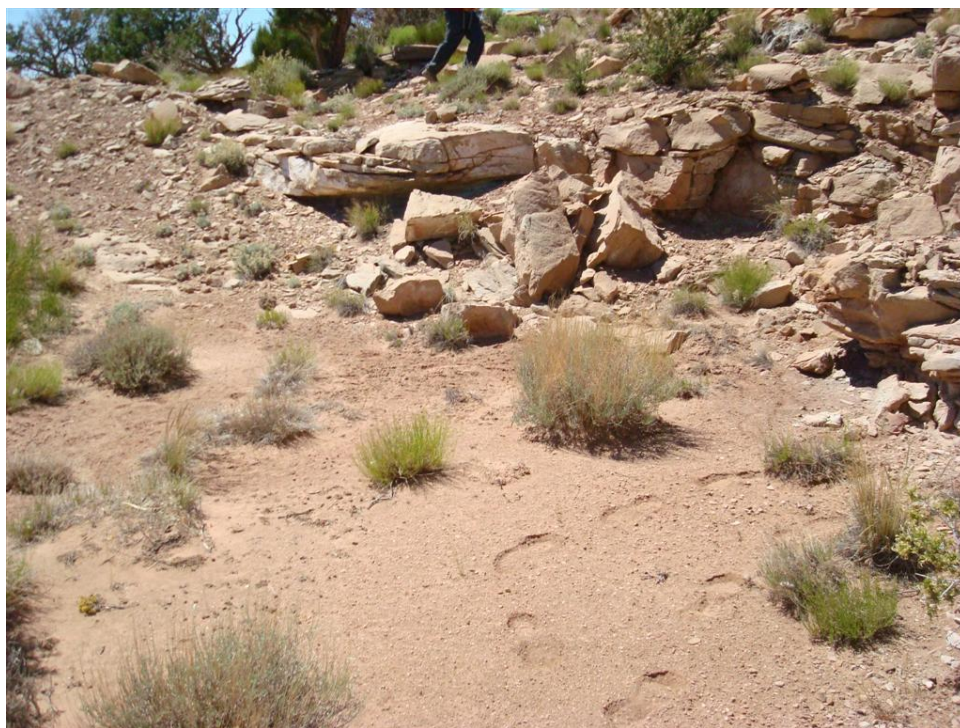
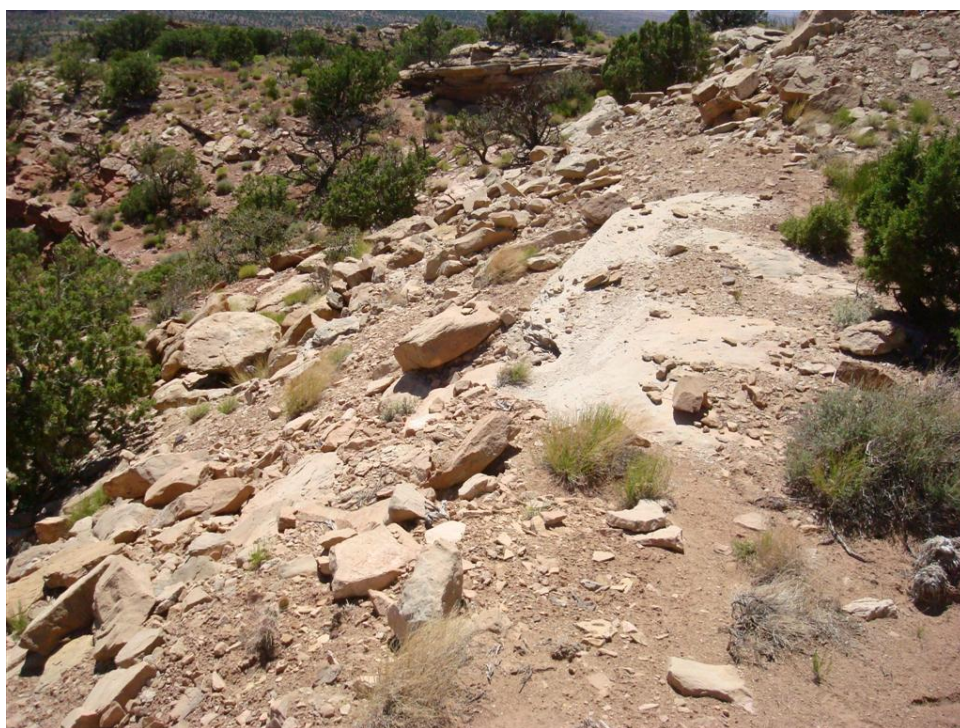
#619 - 1 circular waste pile approximately 400 yd<sup>3</sup>; smaller pile near pit approx 40 yd<sup>3</sup>

#619 - Small excavation pit within waste pile

Photo 6. Plot 15 site #619

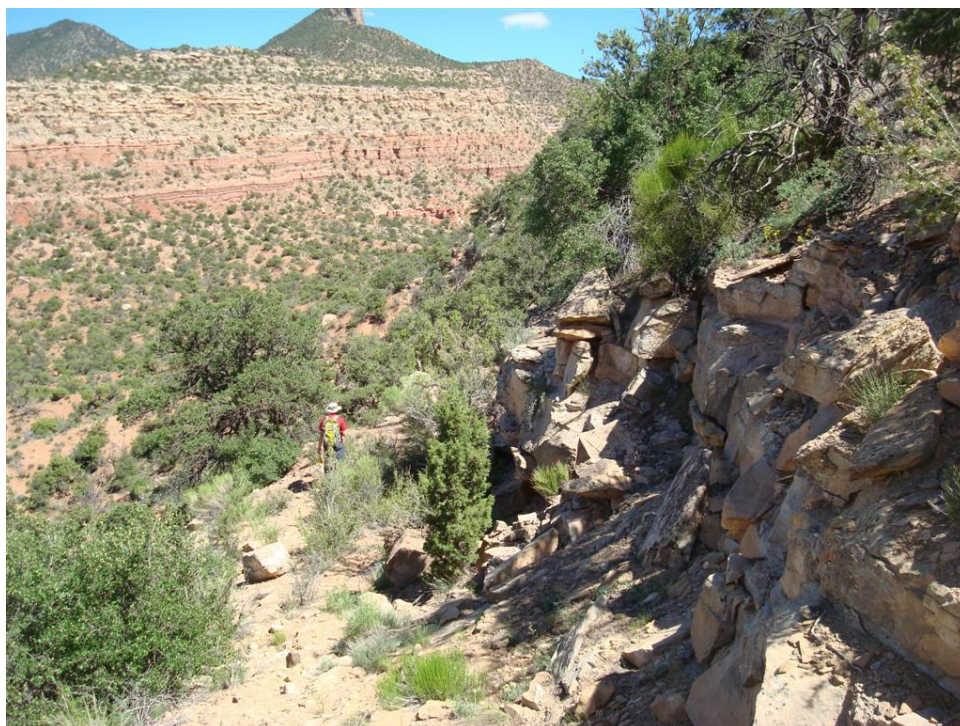
#620 - Waste rock below adits 150'x100'x5'

Photo 9. Plot 14 site #620

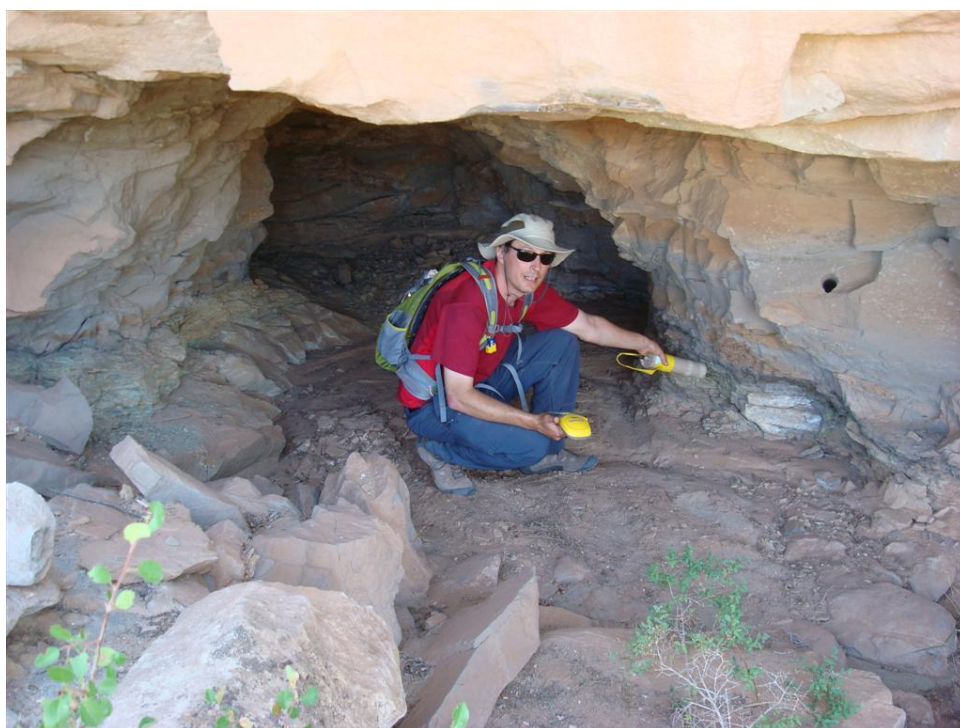
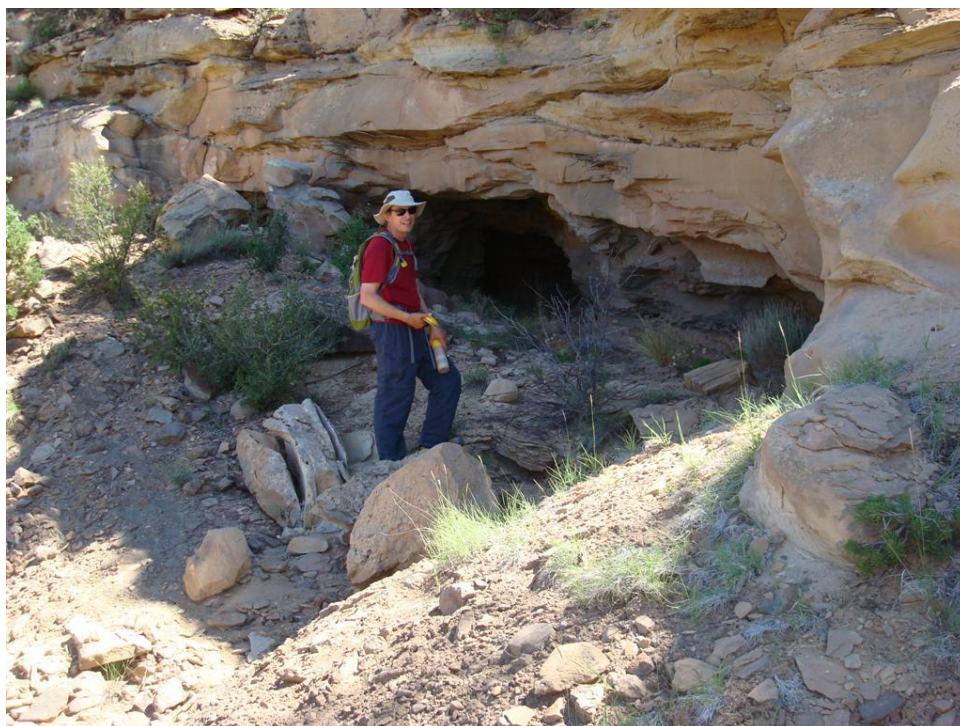
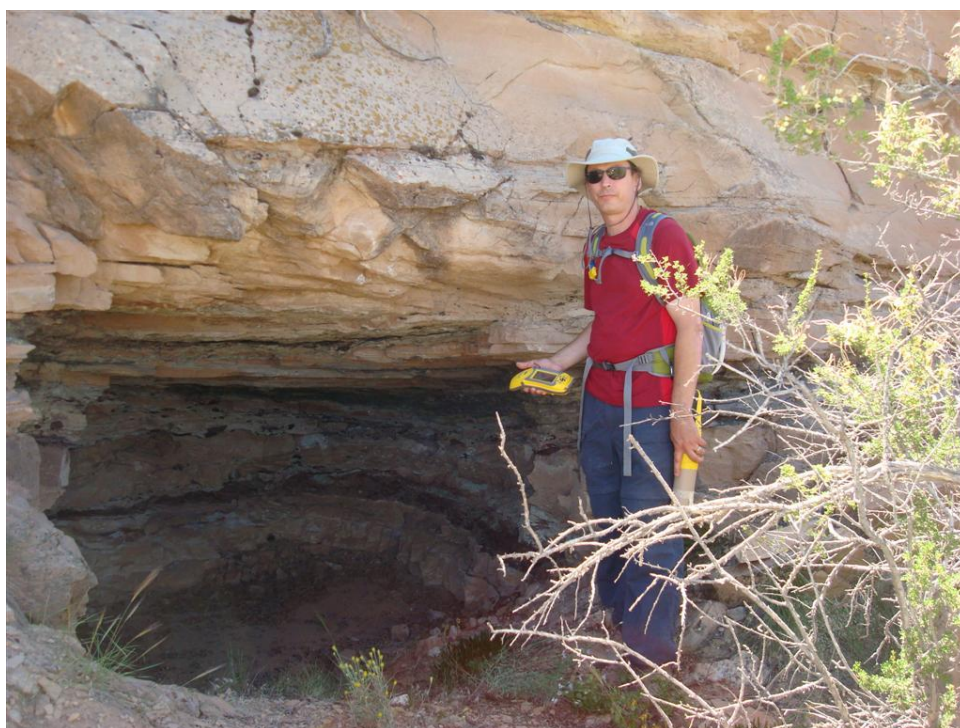
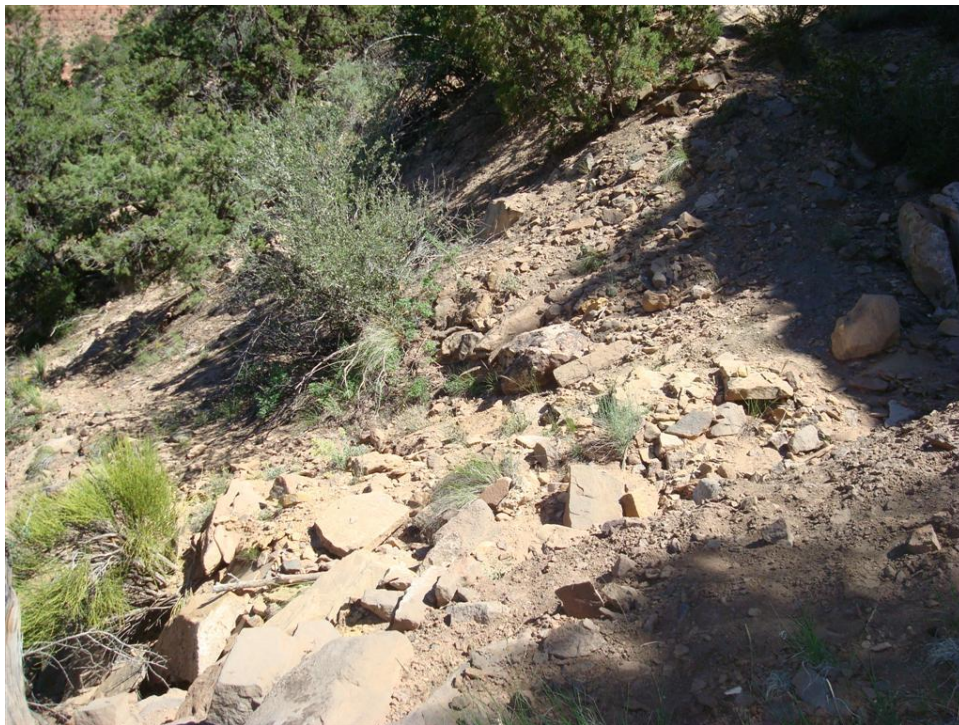
#620 - 2 adits on hillside, one open

Photo 10. Plot 14 site #620, adit

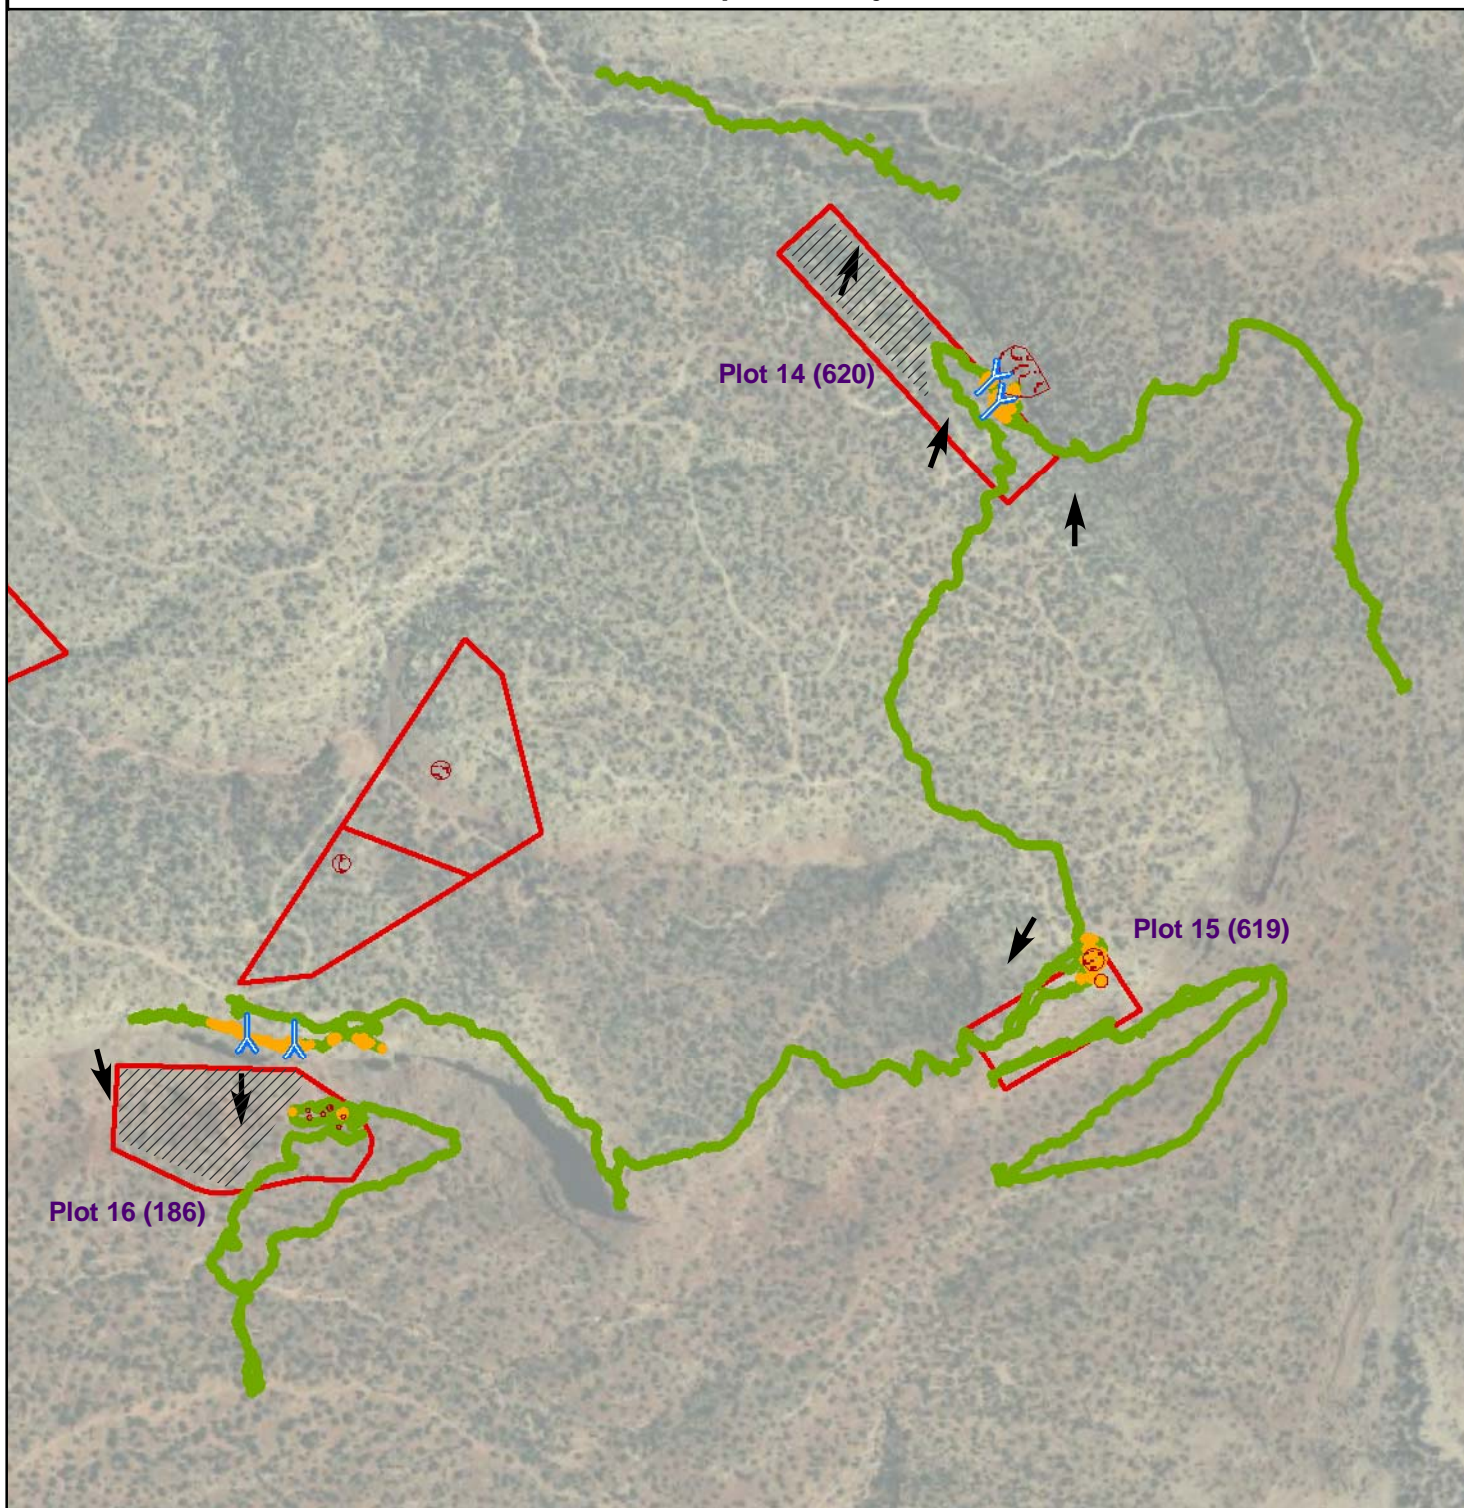
A total of 4,232 gamma radiation measurements were collected from the mine site, ranging from 4,263 cpm to 640,128 cpm. Measurements collected in the vicinity of the waste debris were found at levels up to approximately 600,000 cpm. The measurements are represented in Figures 1 and 2.

A total of 3,587 gamma radiation measurements were collected from the mine site, ranging from 5,899 cpm to 77,442 cpm. Measurements collected in the vicinity of the waste debris were found at levels up to approximately 70,000 cpm. The measurements are represented in Figures 1 and 2.

A total of 2,639 gamma radiation measurements were collected from the mine site, ranging from 5,201 cpm to 999,960 cpm. Measurements collected in the vicinity of the waste debris near the adit were found at levels up to approximately 1,000,000 cpm (the maximum gamma radiation level the equipment can detect). The measurements are represented in Figures 1 and 2.

**Figure 1 - Gamma Radiation Measurements, Above Two Times Background  
Plot 16 (186), Plot 15 (619), Plot 14 (620)  
Sweetwater Chapter, Navajo Nation**
